Docket No. 50-275, OL-DPR-80
Diablo Canyon Unit 1
Licensee Event Report 1-2000-011-00
Manual Reactor Trip Due to Rod Control Failure

LICENSEE EVENT REPORT (LER)

Manual Reactor Trip Due to Rod Control Failure

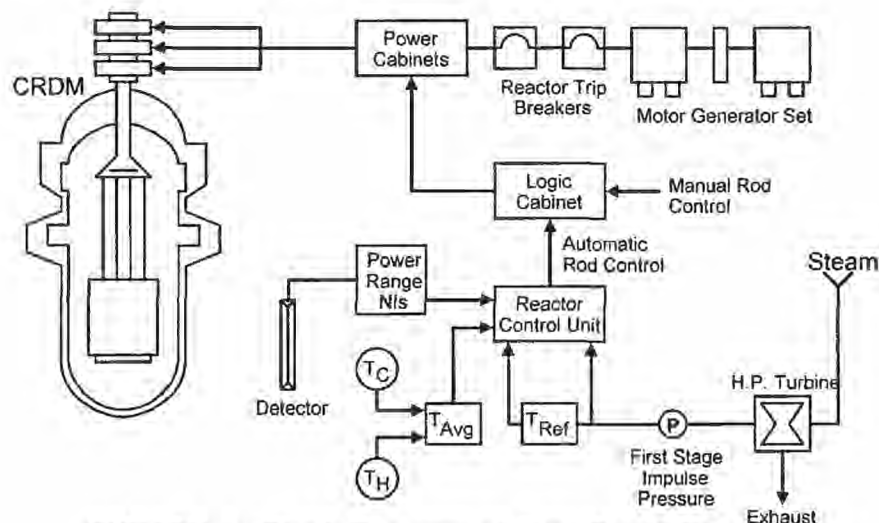
FIGURE 1: Block Diagram of Rod Control System

The urgent failure alarm inhibits further rod motion until the alarm condition is reset. This control feature is provided to stop further rod action that may result in an unintended rod position that could cause an uncontrolled reactivity increase. The rod control system is provided electrical power from the nonsafety-related motor generator set through the safety-related reactor trip breakers. See Figure 1 for graphical detail.
